State of California — The Resources Agency
DEPARTMENT OF PARKS AND RECREATION
PRIMARY RECORD

*Resource Name or #: 116 E. School St.

*P11. Report Citation: Covina Town Center Historic Resource Survey prepared for City of Covina by Historic Preservation Partners (2006-7)

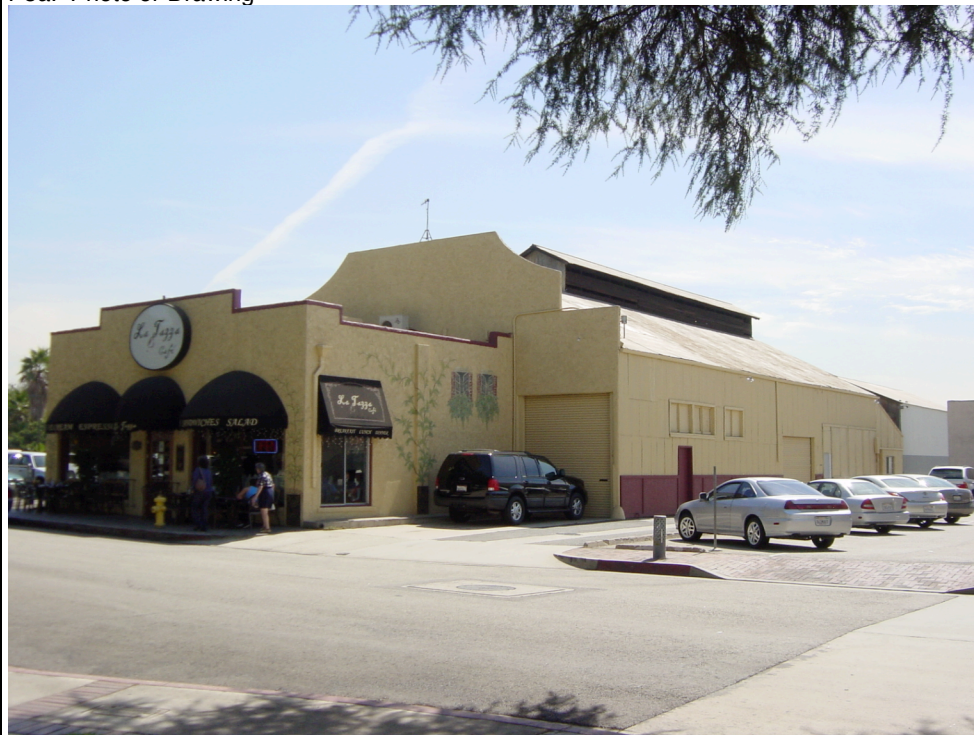
P5a. Photo or Drawing

Potential contributor to Covina's potential Downtown Historic District. 116 East School Street is listed with the Los Angeles County Assessors Office as being a 5,556 sq. ft. building and as having been built in 1905. The building front's North on School. The front section of the building is rough-finished stucco on the façade, however the walls themselves are extremely thick and appear to have been constructed of masonry and adobe. The rear section of the building is constructed out of corrugated metal which has been painted. Clearly an old industrial building, interviews with the historical society and city officials differ in the buildings history, however it is said to now house an electrical part supply warehouse in the corrugated metal section. The front of the building contains a restaurant. Signage above the front door has been added as well as awnings above the front doors and windows. The front (restaurant) section of the building is in excellent conditions. The building itself is quite sturdy and solid. The corrugated metal section of the building is in good condition. The building has the typical shape of a packing house – yet no documentary evidence or personal interviews revealed that this was originally a packing house. As stated above, its original use could not be determined – only its present. However, due to its condition and apparent age, this building should be considered as a potential contributor.

P5b. Description of Photo:
View SE (9/28/06)
